DAMS IN THE DARLING RANGE

Bruce Bulley⁽¹⁾, Bob Wark⁽¹⁾ and Michael Somerford⁽²⁾
(1) GHD Pty Ltd, Perth, (2) Water Corporation of Western Australia

Geotechnical factors play a major role in the design and construction of dams in the Darling Range east of Perth. These factors are described in relation to case histories for a number of water supply dams that have been constructed over the last one hundred years.

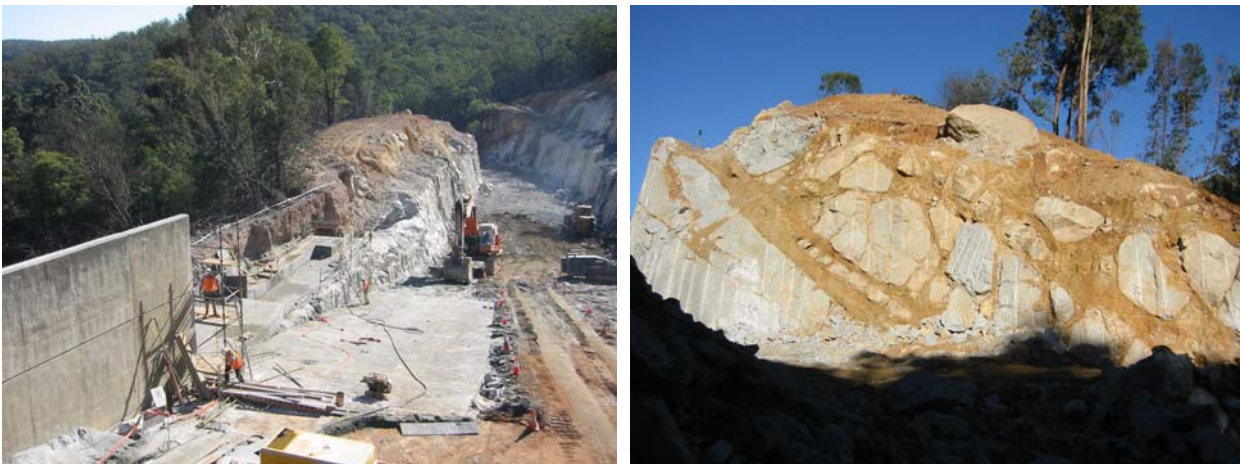
Figure 2: Serpentine Dam – Deepening of the spillway chute (2002) shown on the photograph on the left. The original invert of the unlined chute was at the level of the berm on the left hand side of the photograph. The photograph on the right shows the granite weathering profile. The original floor of the spillway chute was at the top of the cutting on the left of this photograph.

At Serpentine Dam the original spillway excavation had also been cut down to fresh to slightly weathered rock as a side cut on the right abutment. However the variable weathering profile had reduced the available freeboard in many locations and closely spaced open sheet joints containing weathered materials were rapidly eroded when the spillway first operated, resulting in the loss of many thousand of cubic metres of soil and rock (Figure 2). Remedial works consisting of partial lining of the chute were carried out and the spillway was tested the following year. A feature of the test was the significant erosion of the downstream end of the chute due to plucking of blocks from the sheet jointed rock mass. With later reviews of the hydrology resulting in much larger flows being predicted, the decision was made to

deepen the spillway to minimise the risk of loss of the downhill side wall due to back erosion in the variable weathered materials and the along sheet joints. Such a failure could have potentially led to the loss of the main dam embankment.

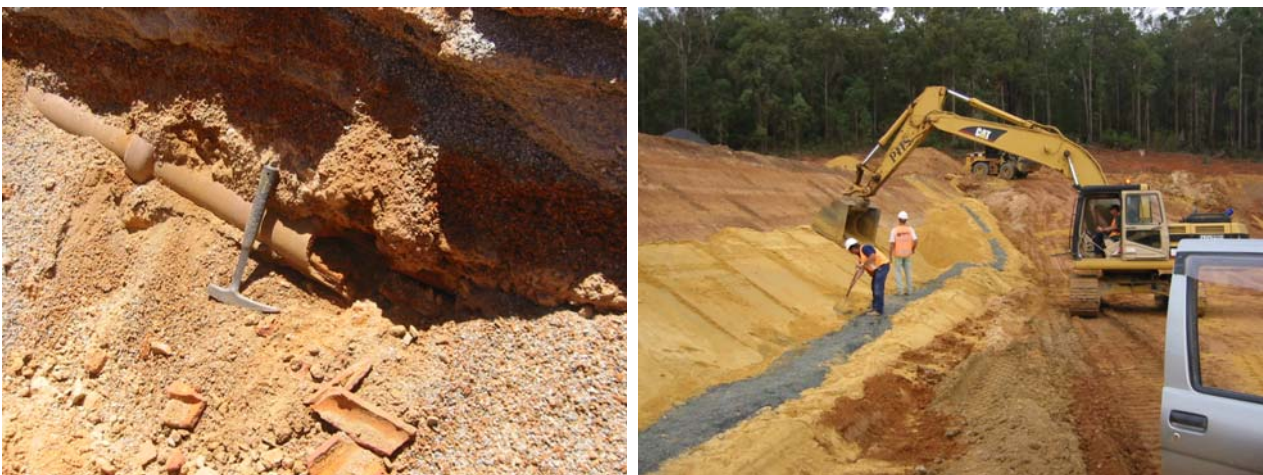
Figure 3: Waroona Dam – Photograph on left showing blockage of the old GEW drainage pipes and the high degree of contamination of the coarse filter media surrounding the pipes. Photograph on the right shows the construction of sandwich chimney filter system consisting of coarse aggregate sandwiched between sand at Waroona Dam in 2002.

The treatment of the problems at the downstream toe has generally included measures such as drainage wells, sandwich filters and toe weighting. The problem with these systems is that the filter and drainage elements tend to block with iron oxide precipitates where the seepage waters are exposed to oxidation on exposure to the air. Complete blockage of the drainage system at Waroona Dam was noted during the remedial works. The earthenware pipes were completely blocked and the surrounding gravel filter media was highly contaminated (Figure 3). Such drainage systems need to be designed so that they can be cleaned and the filter grading needs to be coarse enough to minimise the risk of becoming clogged.

Weighted sand blankets on the toe are rarely successful, as the sand can have a permeability lower than the foundation materials, resulting in an extended seepage path and increased seepage pressures at the toe. To be successful such filter blankets need the sand materials to provide piping protection, but should be overlain by a coarse crushed aggregate. Figure 3 shows a typical sandwich filter treatment under construction at Waroona Dam.

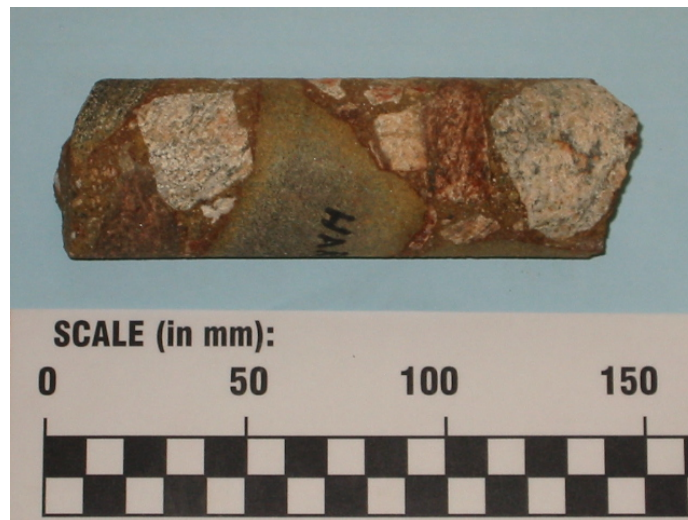
Figure 4: A core sample of the conglomerate from Harvey Dam, indicating clasts of granite and dolerite in a sandstone matrix.

The upper conglomerate horizons consist of a fine matrix containing scattered rounded clasts of quartz and granite. This horizon can be in excess of 10m thick at the site. The upper conglomerate unit has only been observed as a residual soil at Harvey. The lower conglomerate horizon consists generally of abundant angular to sub-angular clasts (gravel, cobbles and boulders up to about 1.5m in diameter) of granite gneiss, metadolerite, feldspar and quartz fragments in a matrix of lithified silty sandstone. The fresh conglomerate is generally massive and unjointed in nature, and forms a low to medium strength rock (Figure 4).

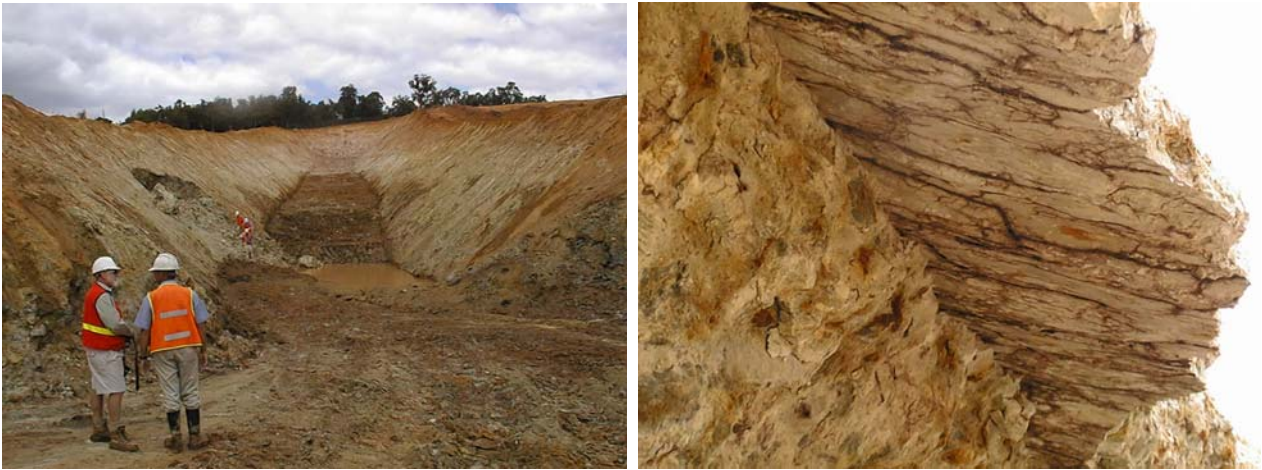
Figure 5: Cut-off trench through upper conglomerate at Harvey Dam (2001), photograph on left showing failure of sidewall along bedding plane surface and steeply dipping joint. Photograph on right showing underside of bedding plane surface.

The original borehole investigation of the upper conglomerate material showed that the upper zones had been extensively lateritised but showed no apparent signs of bedding defects, although a number of variable perched water tables were observed. When the excavations were opened up, a widely spaced set of sub-horizontal bedding plane surfaces and rare oblique joints were observed. The bedding surfaces showed signs of slickensiding. Shear box testing showed that at a value of 17° , the shear strength of the bedding planes was considerably lower than the parent soil, which had tested at shear strengths of 28 to 34° . The bedding planes also acted as preferred seepage paths, accounting for the presence of the perched water tables (Figure 5).

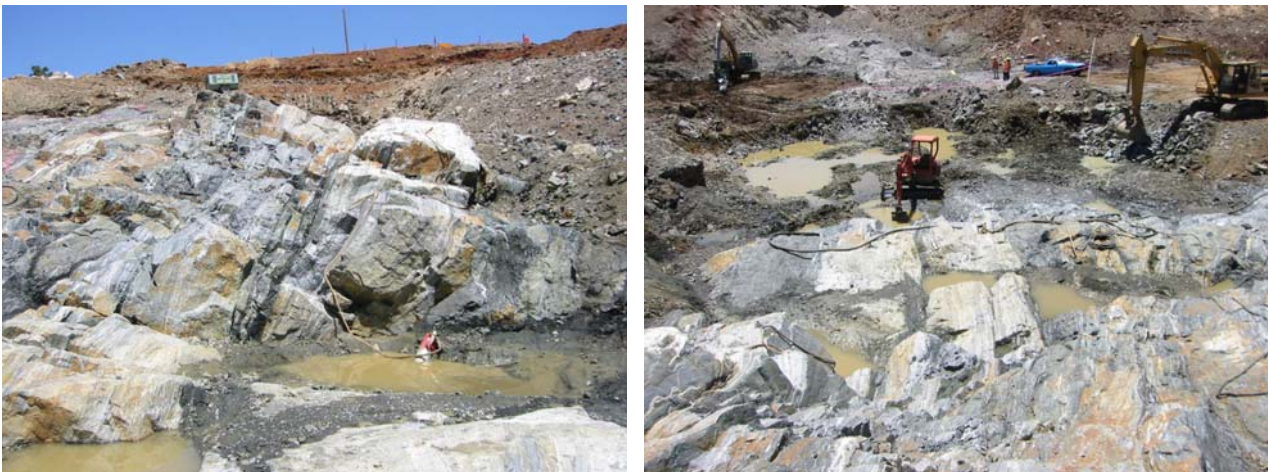
Figure 6: Wokalup Dam (2003) site showing the intense foliation and banding in the gneisses close to the Darling Fault.

The foliation and banding of rocks in the Darling Range typically trend north to north-east with a steep to sub-vertical dip. Joints and contact zones associated with the foliation and banding are frequently planar and continuous over large distances (Figure 6). Slickensiding, indicating movement along the joint or fracture surfaces, occurs along some foliation surfaces and contacts. Preferential weathering also occurs along contact zones and associated joints, with the development of clayey weathering products and commonly chlorite.

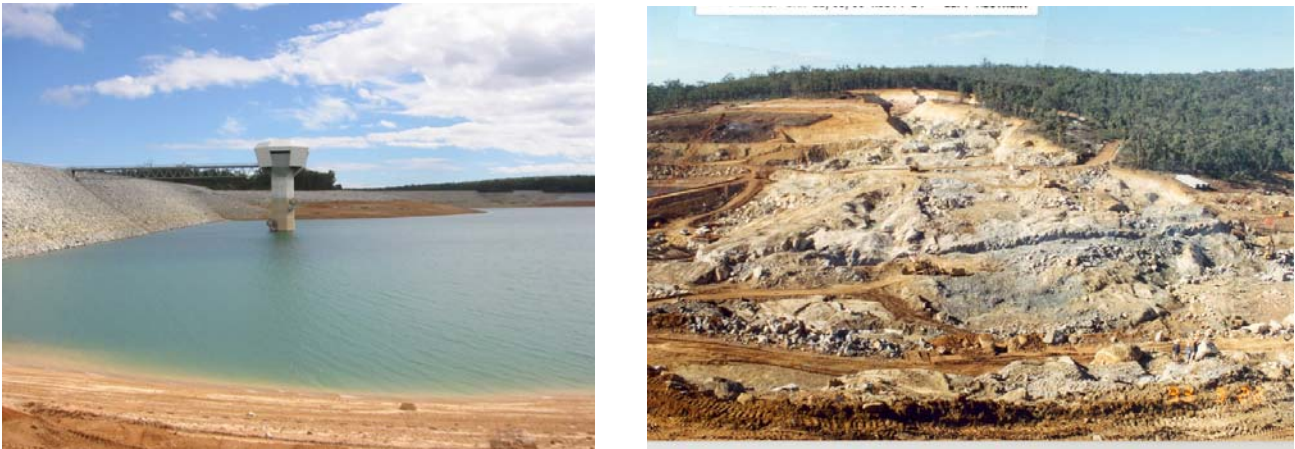
Figure 7: North Dandalup Dam, the corestones on the left abutment (see photograph on the right) caused considerable difficulty in preparing the foundation for the earth core and the rockfill zones of the embankment.

The presence of corestones of hard granitic rock or dolerite within residual soils can present engineering problems in the Darling Range. Corestones display spheroidal weathering features and are formed by preferential weathering of joint bounded blocks of fresh to slightly weathered rock (Fell et al, 1992). Corestones can form significant obstructions in foundation excavations or in cut-off excavations for dams. Extensive zones of corestones were encountered in the cut-off trench and embankment foundation excavations (Figure 7) on the lower left abutment at North Dandalup Dam (Waters and Dart, 1999). The corestones varied in size from half a metre to massive boulders the size of a room. The

corestones were surrounded by extremely weathered material and had to be removed from the excavations by local blasting and additional excavation, to expose the underlying undulatory, slightly weathered to fresh bedrock surface. This resulted in delays to the construction program and deeper excavations than originally anticipated.

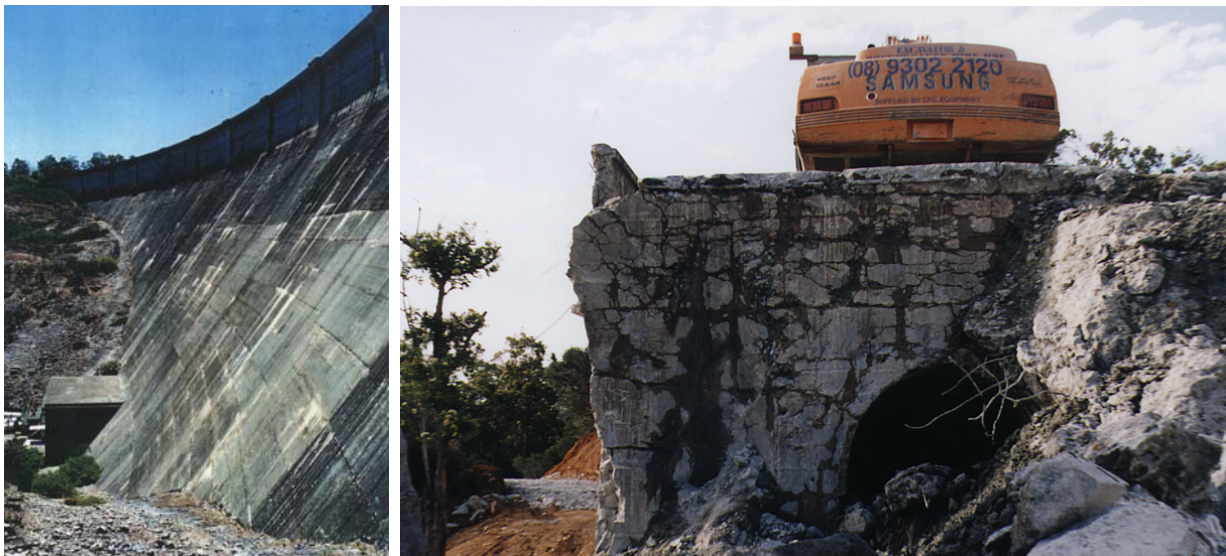
Figure 8: Canning Dam, the photograph on the right shows the extensive cracking in the region of the upper gallery, believed to have been caused by AAR.

Canning dam had also been subject to considerable cracking of the upper parts of the dam and upper gallery (Figure 8). Investigations have shown that the cracking was due to a strong AAR in the concrete, which has been related to the presence of deformed granite and gneiss aggregate (Shayan et al, 2000). Petrographic examination of the aggregate
